# ESTD/ E-18-01

## XINXIN - Gansu, CHINA

### Project Description

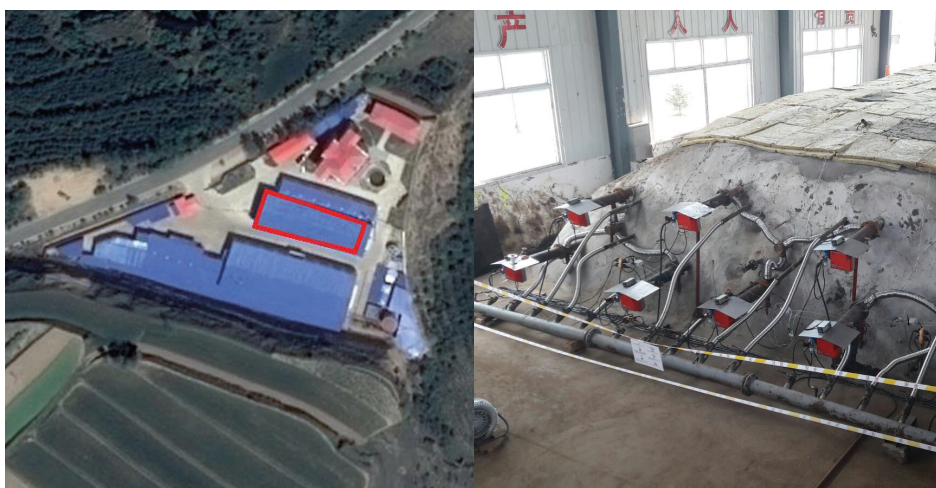
Before the build-up of the pile, stability tests were done with different types of soil to select the appropriate wetness and consistency of soil to build the pile. Since the pile was build up in a hangar, the access to the pile was limited. During the building of the pile, different layers of more or less contaminated soil were setup. The ESTD treatment facility was set as shown on the picture below.

The project is setup in a hangar on a surface of about 250m<sup>2</sup> with 9 diesel burners and a vapor treatment unit. The treatment area is impacted with various solvents. The targeted concentration at the end of the treatment is 3000 mg/kg. The treatment began on July 27th, 2017 and ended on October 27th of 2017, which gives a total treatment time from the beginning of 90 days.
