# LNAPL SKIMMING/ D-16-03 FLAWINNE (BE)

## Origin of the incident

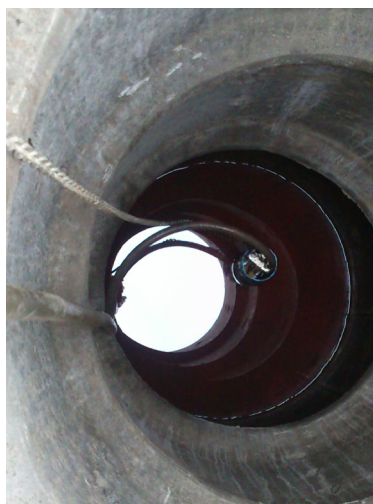
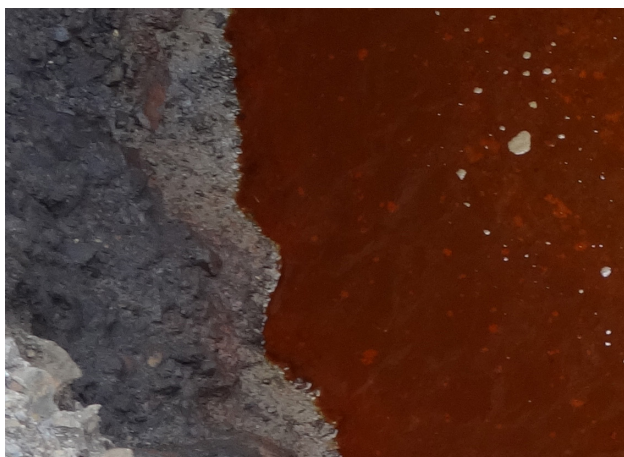
- Emergency response shortly after discovering the incident.
- Delivery and implementation of a pumping unit DS 500-12 accompanied by a 1m<sup>3</sup> outdoor storage IBC.
- Placement of a floating dam on the canal with free phase suction using a SKIMMER 600.
- Digging of 6 open pits with a 4.5 m depth, of which 4 were subsequently lined. Wells were equipped with 2 SKIM 4-25 moved from well to well according to the needs. The pits were equipped with SKIMMER 600.
- Recovery of HC in the excavations, no draw-down in the first phase. Subsequently, drawdown was set up to block migration towards the canal.

- Over a period of 8 months, recovery of 6M<sup>3</sup> of pure product.
- 90% of the total volume were recovered during the first 4 months.
